**GOVE DIKE  
NH 00135**

**STATE NO 184.03**

**PHASE I INSPECTION REPORT  
NATIONAL DAM INSPECTION PROGRAM**

**JULY 1978**

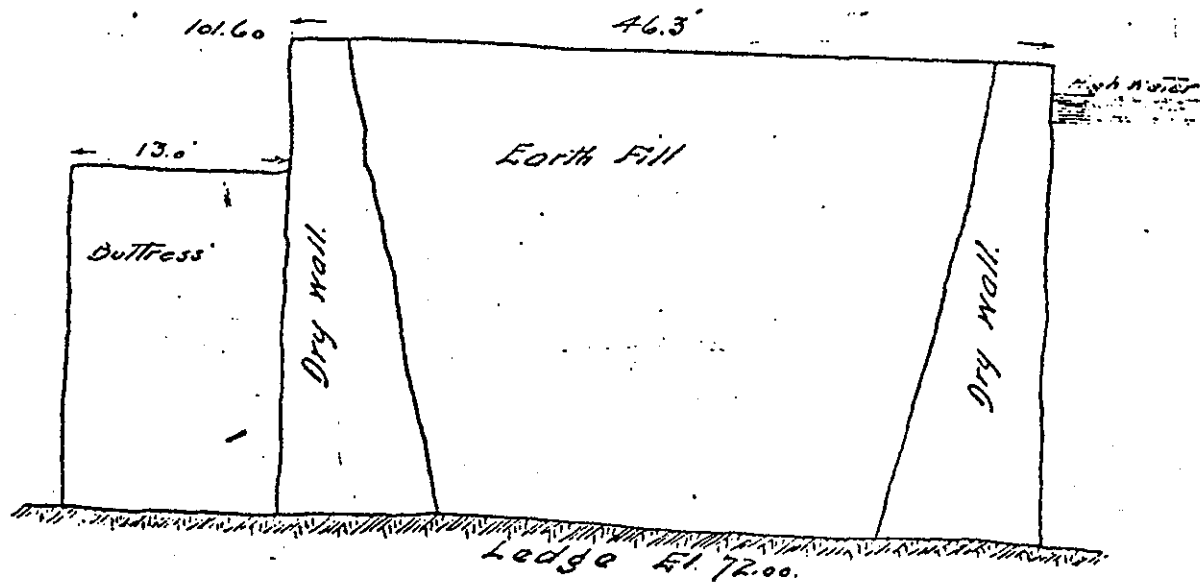
Cross Section  
of  
MENDUM DAM  
Nottingham & Barrington N.H.  
Scale 16 to the inch.  
Copied Nov. 1918. by J.H. Litchfield  
from drawings in a report by  
H.M. Oliver, C.E. to the Newmarket  
Manufacturing Co. dated 1889.

There are however three places where steel tie-rods should be introduced at a depth of about eight feet from the surface to check further outward movement at points where the overhang or bulging amount to 12 or 14 inches. The tie-rods should be not less than  $2\frac{1}{2}$  inches in diameter with upset ends and provided with washers or crabs 3 or 4 feet in diameter. The location of the rods and a section is shown in Fig. 2 on the last sheet attached to this report. The rods should be free from rust bedded and packed in fine gravel concrete in proportions 1, 2, 3. Very little need be used. The exposed parts should be painted. Then with general supervision and economic control the reservoirs should continue for a long time to give good service without causing you any anxiety or disquiet.

At the Mendum reservoir there is less need to make changes. The bottom of the present spillway should be brought to a uniform level and all growth of small trees and obstacles of all descriptions, driftwood, old stumps, etc. should be removed and the entire space kept clear. One further recommendation needs attention at your convenience. The upstream wall at Mendum's is of very large rough stone, boulders for the most part, and at two or three places these have cracked under the pressure which has been concentrated at various points by the removal, through frost action in nearly a hundred years, of many of the smaller stones used in construction to level up and give added bearing surface. Last month many restorations to early conditions were made by replacement without mortar, but with much work and careful attention to strengthening the wall.

Changes to be made at Menduin Dam.
